Approach for analyzing landslide and torrential flow hazard conditions in relation to landscape evolution in the northern Colombian Andes

Karolina Naranjo Bedoya¹, Edier Aristizábal Giraldo¹, Daniel Höbbling², John García¹, Asaf Aguilar¹, David Ortiz¹

¹Departamento de Geociencias y Medio Ambiente, Universidad Nacional de Colombia, Medellín Colombia,

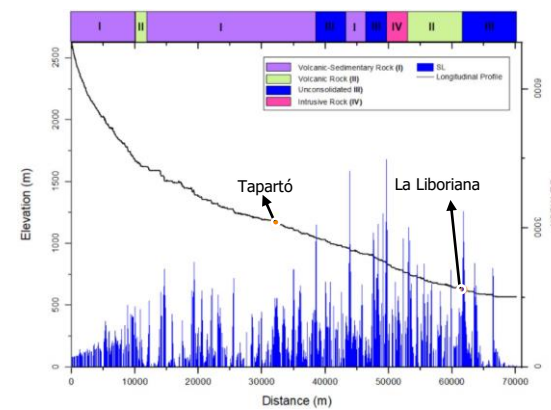
Longitudinal profile

Reflects change in high SL values

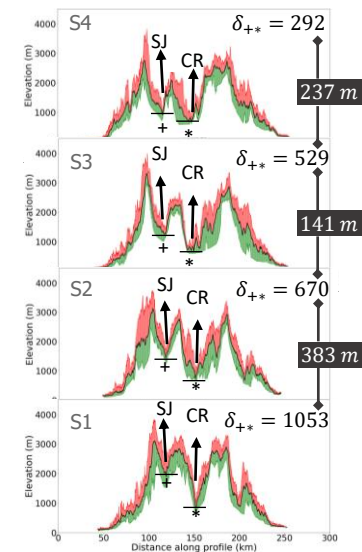
Swath profile High incision
